# 28,000 Hour Xenon Hollow Cathode Life Test Results

Timothy R. Sarver-Verhey  
NYMA, Inc., Brook Park, Ohio

Prepared for the  
25th International Electric Propulsion Conference  
sponsored by the Electric Rocket Propulsion Society  
Cleveland, Ohio, August 24-28, 1997

**The International Space Station Plasma Contactor System requires a hollow cathode assembly (HCA) with a lifetime of at least 18,000 hours. Critical components of the HCA include the hollow cathode and electron emitter. A series of hollow cathode wear tests was performed which included a life test operated at the maximum current of the HCA. This test sought to verify the hollow cathode design and contamination control protocols. The life test accumulated 27,800 hours of operation before failing to ignite. The hollow cathode exhibited relatively small changes in operating parameters over the course of the test. This life test is the longest duration test of a high current xenon hollow cathode reported to date.**

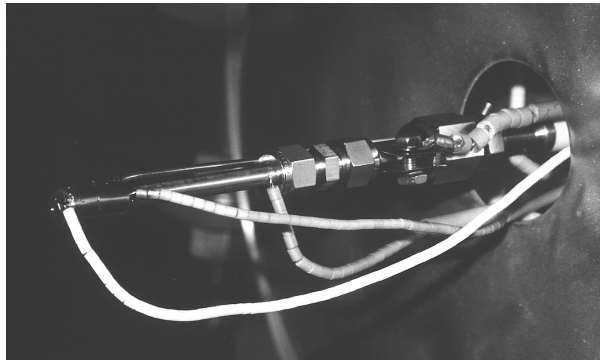
**Figure 1. Life test hollow cathode.**

The hollow cathode, shown in Fig. 1, is similar to the flight HCA cathode.<sup>3</sup> Like the HCA cathode, it consisted of a refractory metal tube with a plate welded to one end. The plate has a small orifice with a chamfer on the downstream surface. The electron emitter consists of a porous sintered tungsten cylinder impregnated with barium-containing compound placed in the downstream end of the tube. Electrical leads, attached to the rear of the electron emitter, were welded to the interior of the upstream end of the hollow cathode tube. These leads provided electrical contact and maintained the position of the emitter in the tube.

A sheathed heater, used for conditioning and ignition, was fitted on the outside of the cathode tube over the region occupied by the electron emitter. Several layers of metal foil were wrapped around the heater to reduce radiated power losses.

During the test, cathode temperature measurements were made with three thermocouples attached to different locations on the cathode body (see Fig. 1) and with two pyrometers sighted onto different locations on the cathode. The pyrometers used were a disappearing filament (DF) pyrometer and an infrared (IR) thermometer.

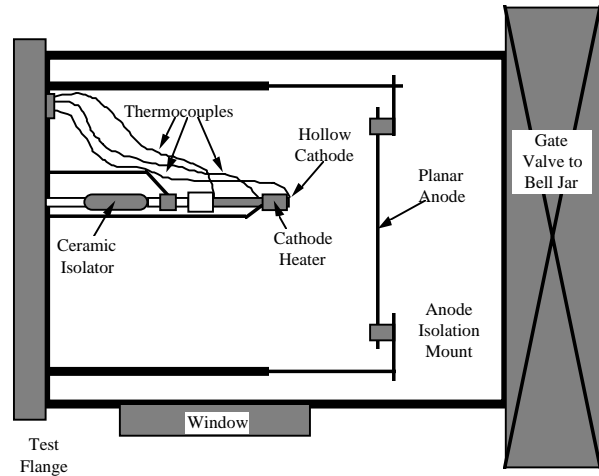
**Figure 2. Schematic of life test configuration.**

The life test was performed in a diode configuration with a planar anode mounted approximately 6 cm downstream of the hollow cathode (see Fig. 2). Information pertaining to test configuration, feed system design, power supplies, and instrumentation was provided in an earlier report.<sup>16</sup>

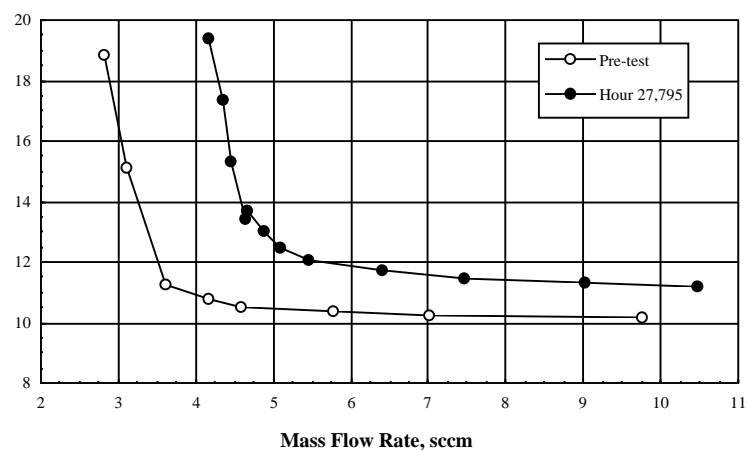
**Figure 3. Anode voltage vs. xenon flow rate before and after life test.**

The hollow cathode was characterized repeatedly during the test by measuring the anode voltage and cathode temperatures under variation of xenon flow rate. The voltage and temperatures are the dependent operating parameters of the cathode and reflect changes in condition. Figure 3 shows the pre- and post-test behavior of the anode voltage as a function of the xenon flow rate at a fixed emission current of 12 A. At the start of the life test, the anode voltage increased rapidly at flow rates below approximately 3.6 sccm. By the end of the test, the anode voltage increased rapidly at flow rates below about 4.8 sccm. In addition, the anode voltages were higher at all flow rates. Characterizations performed during the test agreed with the trend shown in Fig. 3.

The nominal anode voltage at the life test flow rate increased by approximately 16% during the test. While this increase is indicative of changing cathode condition, it was within the bandwidth observed during previous HCA cathode life tests.<sup>11</sup> Additionally, the anode voltage during this life test was always significantly lower than the maximum allowable anode voltage of 40 V for the HCA.<sup>3</sup> Consequently, voltage increases simi-

The physical conditions of the hollow cathode and electron emitter are presently being evaluated. The pre- and post-test conditions of the hollow cathode are shown in Figure 7. Preliminary results indicate that the cathode orifice was generally in good shape and increased in diameter by approximately 14%. This change is believed to be sufficient to cause the shift in cathode operation shown in Fig. 3.

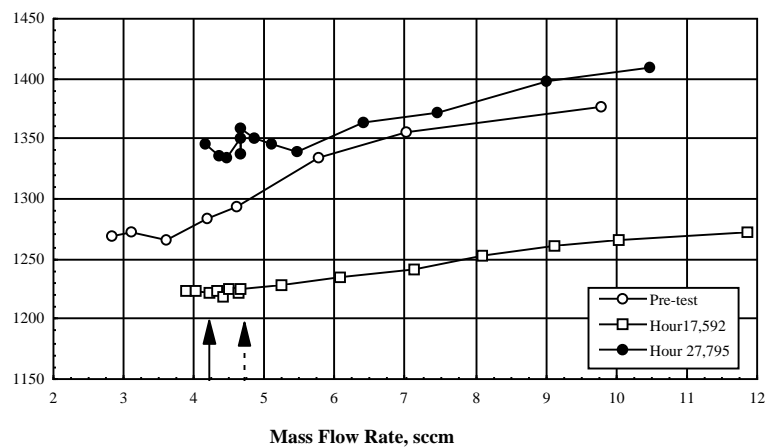
**Figure 4. Hollow cathode operating temperature vs. xenon flow rate. All data taken with a disappearing filament pyrometer at a fixed emission current of 12 A. The arrows indicate the life test flow rate set point (solid line - pre-test; dotted line - Hour 27,795).**

The effect of flow rate on cathode tip temperature over the course of the test is shown in Figure 4. The pre-test data and the data obtained at hour 27,795 exhibited comparable operating temperatures over much of the flow range. However, at the life test flow rate, the tip temperature increased by approximately 50 °C over the course of the test. This increase resulted in the hollow cathode operating near the cut-off temperature of 1,350 °C (DF pyrometer reading), which is discussed below.

Measurements taken during the life test up to the 23,776 hour mark were consistently and substantially lower than the pre-test and final temperature measurements over the entire flow range. This is illustrated in Fig. 4 by the data taken at hour 17,592. This data set was selected at random as a typical example of this behavior. After 23,776 hours, the tip temperatures below 4.6 sccm exceeded the pre-test values.

The cathode temperature exhibited the greatest sensitivity to xenon flow rate at the beginning of the life test. By the end of the life test, the cathode could not be operated below 4.2 sccm without the DC and AC components of the anode voltage rising significantly. The HCA flow rates were selected to ensure that the cathode does not operate near this region with significant DC and AC anode voltage components.<sup>3</sup> Therefore, this effect is expected to be inconsequential for the ISS program.

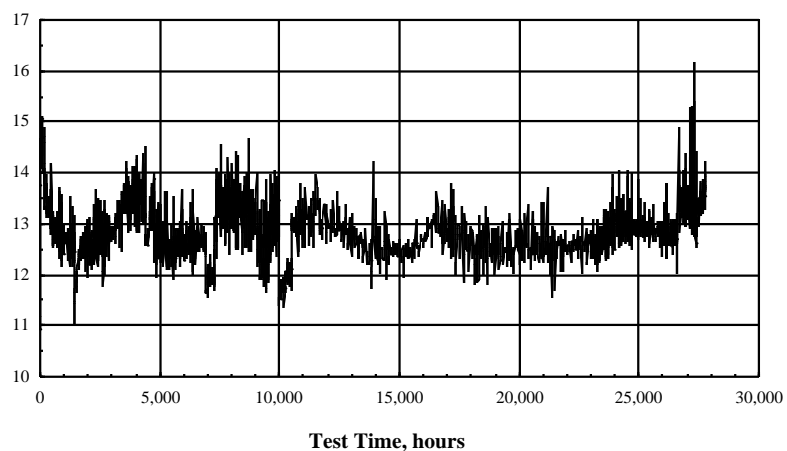
**Figure 5. Anode voltage vs. test time.**

Hollow cathode performance during the life test was determined by monitoring the anode voltage and cathode temperatures. Figure 5 shows the behavior of the anode voltage as a function of test time. Two types of voltage variations were observed. First, the anode voltage varied over a period of several thousand hours with a mean value of 12.9 V. The range of this voltage variation is listed in Table 1.

Second, nominal daily voltage variations of approximately  $\pm 0.3$  V resulted from changes in xenon flow rate caused by ambient laboratory temperature changes. This variation appears as the noise on the anode voltage measurement in Fig. 5. The corresponding flow rate changes were typically  $\pm 0.2$  sccm.

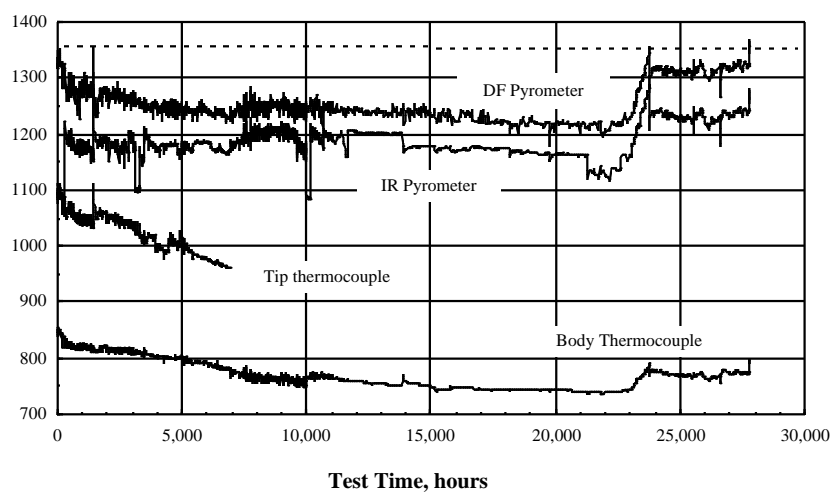
**Figure 6. Cathode temperatures vs. test time. Temperatures measured with two thermocouples and two pyrometers. The dashed line indicates the life test cut-off temperature.**

Cathode temperatures, measured with two thermocouples and two pyrometers, are shown in Figure 6 as a function of test time. The temperatures exhibited two variations during the life test. The first variation was that the temperatures all decayed continually until approximately hour 23,000, at which time the temperatures started to rise rapidly.

For the test, a shut-down criterion of 1,350 °C (DF pyrometer reading) maximum cathode tip temperature was established in order to ensure that the condition of the hollow cathode and electron emitter were preserved against rapid changes due to operation at increased temperature. The cathode tip temperature rose until this value was reached at hour 23,776 and the life test was stopped for evaluation.

After flow meter recalibration and a feed system integrity check failed to identify any test support equipment problems that may have accounted for the cathode tip temperature increase, the life test was resumed. The cathode tip temperature subsequently stabilized approximately 1,315 °C and remained there for approximately 4,000 hours. The tip temperature then exceeded the 1,350 °C limit at approximately hour 27,795.

The second observed temperature variation, shown in Fig. 6, was the result of the daily variations in xenon flow rate due to laboratory ambient temperature changes. Because of the flow rate variations, the tip temperature measurements using the DF pyrometer varied by approximately 30 °C.

Three temperature 'spikes' occurred during the life test. The first occurred during the anomaly at hour 1,467. The second and third spikes occurred when the cathode tip temperature met or exceeded the cut-off temperatures at hour 23,776 and 27,800.

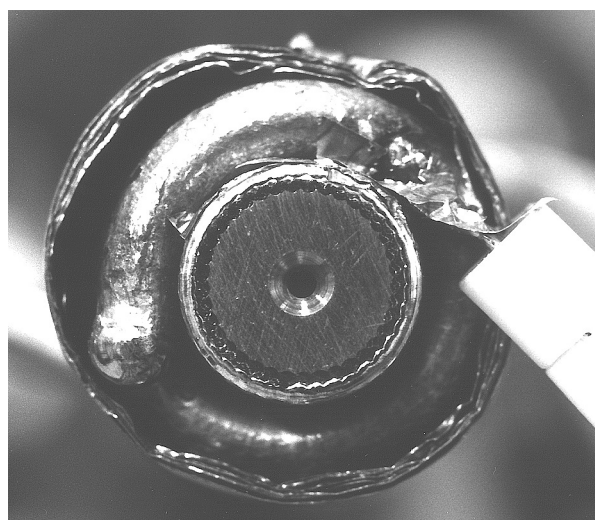
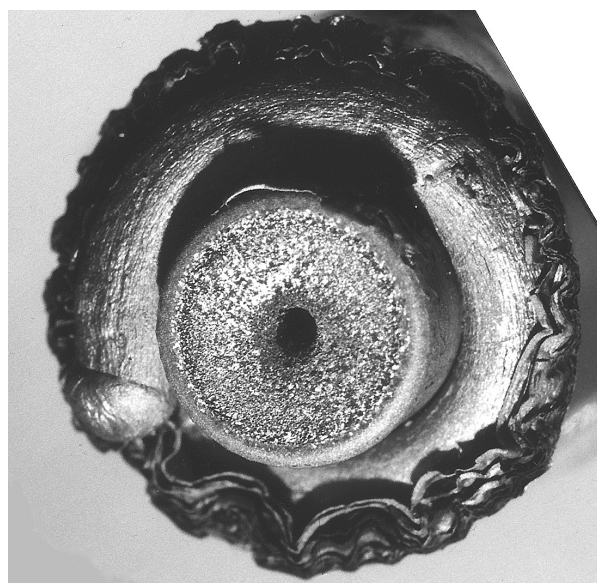
**(a)**

**Figure 7. End view of the life test hollow cathode. (a) Pre-test. (b) Post-test.**

In addition, the orifice plate and cathode exterior surfaces were textured by ion bombardment, though the erosion was not sufficient to remove surface features (i.e orifice plate weld structure, orifice chamfer, sheathed heater surface).

Finally, the sheathed heater radiation shielding was found to be severely eroded, with the exposed surfaces exhibiting degradation. This erosion is attributed to ion bombardment due to operating the cathode with a planar anode that resulted in significant exposure of the
